# Impacts to Highway 8 British Columbia due to the November 2021 Atmospheric River Event

Michael J. Laws

Ryan Edmonds

**GeoCalgary**  
2022<sup>October</sup>  
2-5  
Reflection on Resources

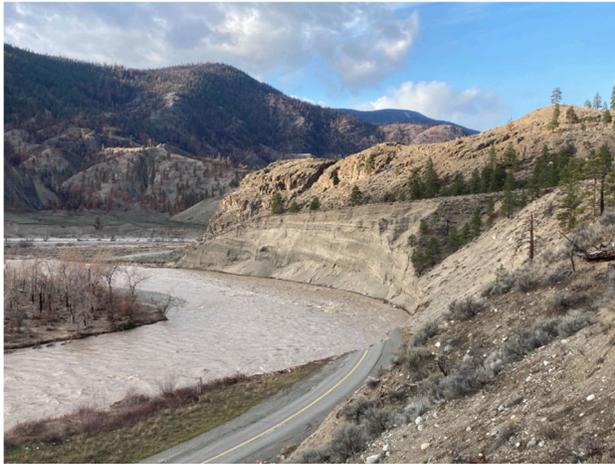
Damaged highway sections consisted primarily of erosion due to elevated water levels/flows of the Nicola River. Most of the damage sites occurred where the Hwy 8 alignment was situated on outside bends of the Nicola River and in-situ soil conditions consisted of erosion prone soils. Sites 4, 5 (See Figure 8), 8, 10, 11, 13, 15 and 18 experienced significant erosional damage resulting in near vertical slopes ranging in height from 5 to 40+m.

Figure 8. Highway 8 – Site 5 Typical Erosion Damage.

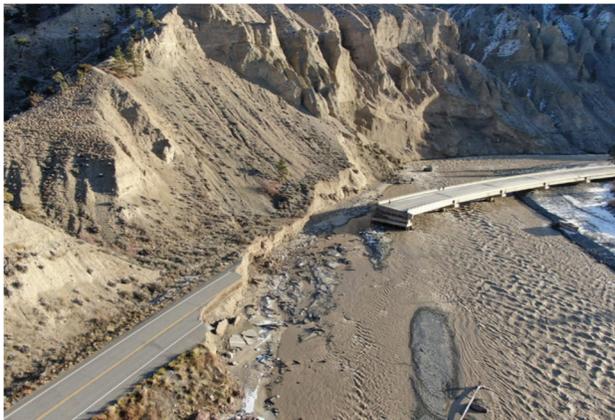
Three Mile, Rattlesnake and Curnow Bridges all suffered from abutment damage, with major scour and erosion of the approaches on all three structures. Three Mile and Rattlesnake bridges suffered significant erosional damage to the bridge approaches and scour of the abutments, while Curnow Bridge suffered mainly scour of the abutment. Figure 9 depicts structural damage.

Figure 9. Highway 8 – Site 21 Rattlesnake Bridge Approach and Abutment Damage.

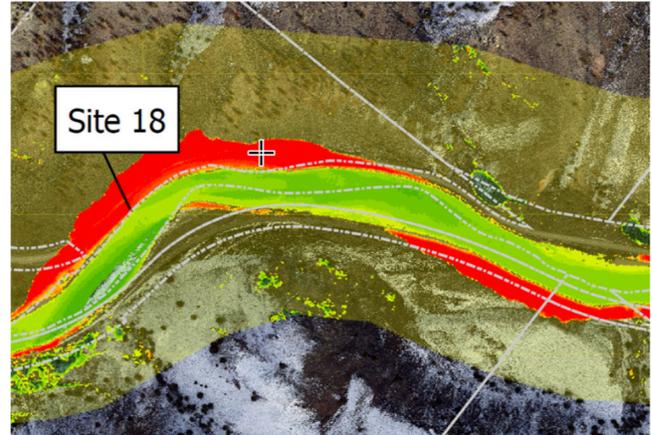
LiDAR (Light Detection and Ranging) remote sensing technology was used to detect damage that occurred due to the event. Flights conducted in November 2021, shortly after the event, were compared with the previous 2017 LiDAR and change detection analysis was completed. An example of this change detection is shown on Figure 10.

Figure 10. LiDAR Change Detection Results for Site 18. Red Denotes >3m of Vertical Change.

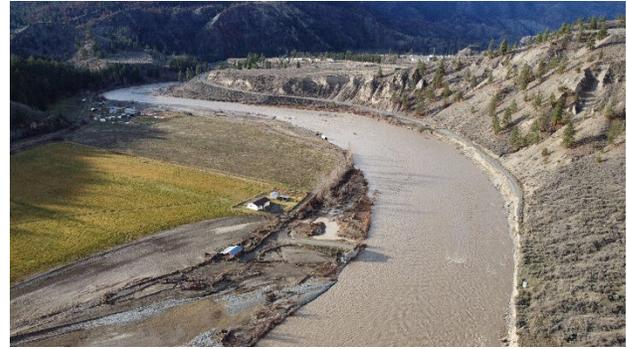
Artificial restriction typically comprised bridges with insufficient hydraulic capacity to pass the peak flood flows. Field observations at bridge locations noted a backwater affect with silt deposition from a pronounced lake immediately upstream of several bridge crossings. Inferred high water observations indicated that maximum flow depths reduced over 1.0 m immediately downstream of several destroyed bridge crossings.

The magnitude of flood damage observed immediately downstream of several destroyed bridge crossings suggests that a peak flow (pulse) potentially greater than that generated by runoff due to bridge may have occurred and that cascading failure of several bridges may have occurred. Figure 12 depicts silt deposition upstream of a pre-event bridge crossing.

Figure 12. Highway 8 – Site 4. Silt Deposition Indicating Backwater Affects Due to Upstream Bridge.

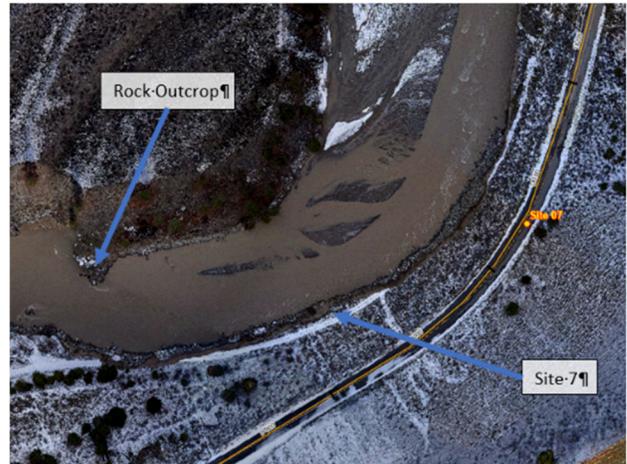
The erosional damage at Site 7 was influenced by a natural rock outcrop present in left bank of the river at the upstream end of the site which restricted and deflected flows towards the right bank as depicted on Figure 13.

Figure 13. Highway 8 – Site 7. Example of Natural Hydraulic Restriction.

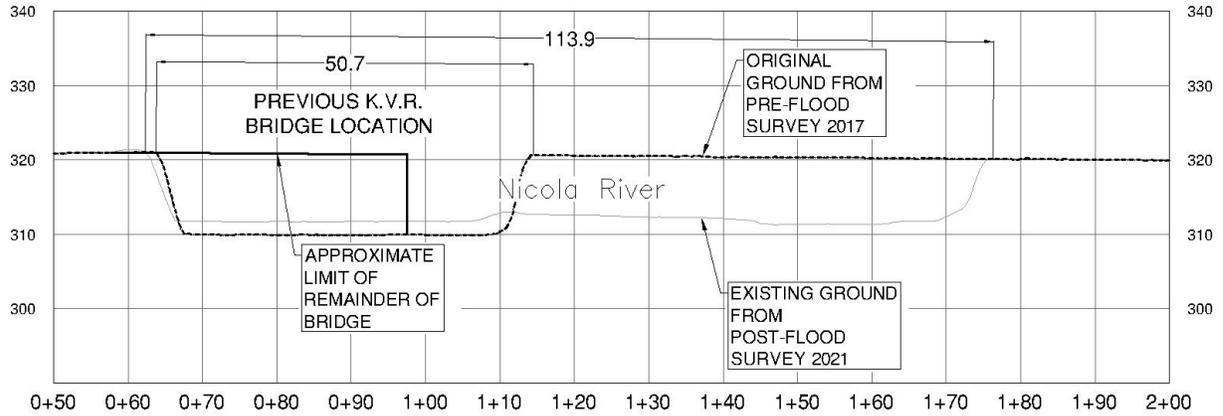
At the upstream end of Site 10 an old railway bridge associated with the Kettle Valley Railway was present prior to the flood with a maximum opening of approximately 50 m. During the flood the left abutment was undermined causing a jump span to collapse. The resulting flood wave eroded the left abutment back approximately 60 m increasing the river width to approximately 110 m at this location. Figure 14 illustrates the former location of the railway bridge and subsequent erosion.

Figure 14. Highway 8 – Site 10 Section Through KVR Bridge

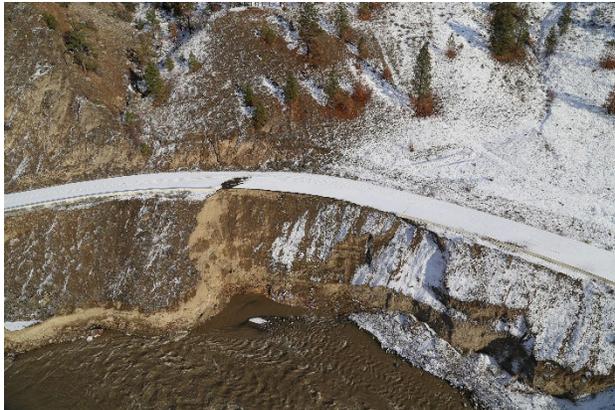
Most of the erosion sites have slope instability hazards comprising either sections of undermined and over steepened highway embankment and/or significantly eroded slopes forming escarpments above the highway alignment. Figures 15 and 16 depict a typical example of undermined highway embankment and escarpment formation, respectively.

Figure 15. Highway 8 – Site 5. Example of Undermined Section of Highway Embankment.

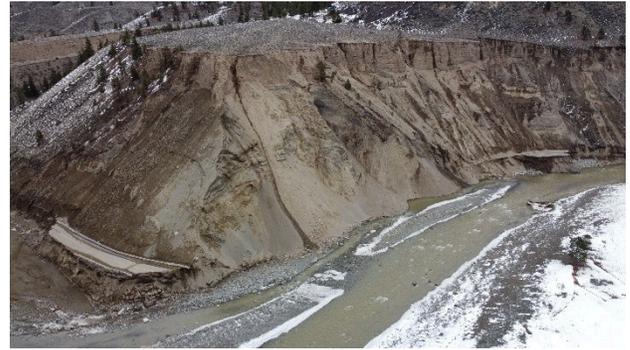
Several small debris flows associated with seasonal drainage features and groundwater seepage were encountered in areas with loose glacial drift colluvium.

Figure 16. Highway 8 – Site 10. Example of Escarpment Formation Above Highway Alignment and Small Debris Flow.

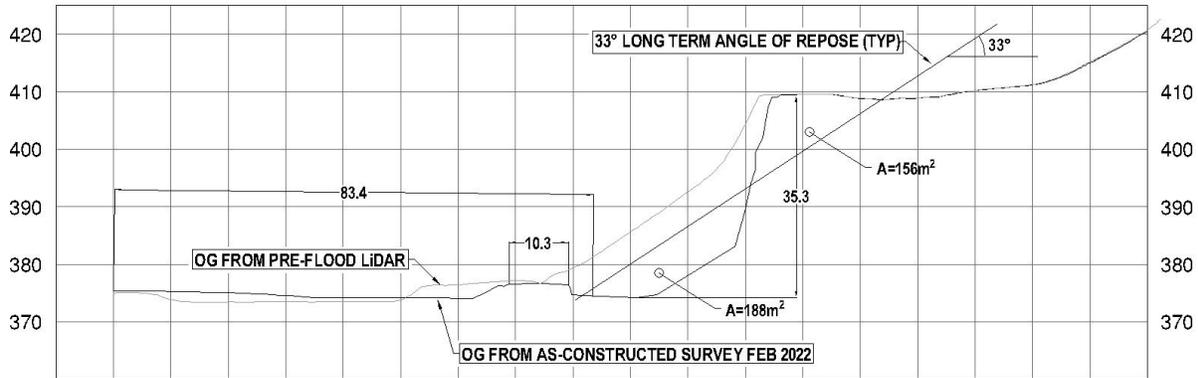
Figure 17. Highway 8 – Site 5. Example of Determining Safe Set Forward Distance from LiDAR.

Where possible, the highway response works were constructed along the pre-flood highway alignment, however this was not always considered feasible at some sites due to the presence of the geohazards created by the flood. Where significant landslide hazards were present the response works were constructed using a safe set forward distance from the hazardous slopes based on determining the long-term angle of repose of historical slope performance from the pre-flood LiDAR. An example of safe set forward distance is depicted on Figure 17.

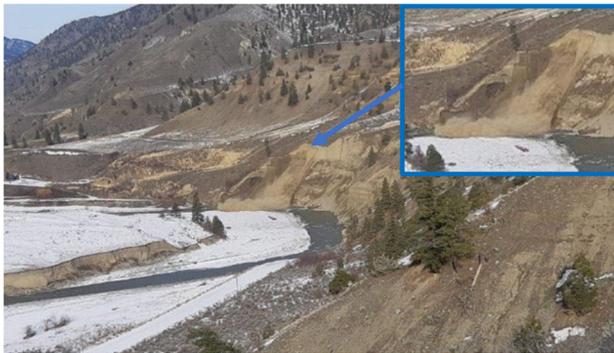
decision to shift the temporary highway alignment to the abandoned Kettle Valley Railway corridor along the left back of the Nicola River. During construction of the response works, several post flood landslides were observed within the glacial drift escarpments, with one notable slide observed on February 5, 2022 within Site 10 and illustrated (inset) on Figure 18.

Figure 18. Highway 8 – Site 10. Landslide February 5, 2022.
