Trenchless Utility Installation Ground Loss Soil Stabilization Emergency Action Plan for Rail Tracks – Case Study

Mr. Kyle L. Haugrud, P.Eng., Senior Geotechnical Engineer
Mr. Joseph Yonan, Ph.D., P.Eng., Principal Geotechnical Consultant
Tetra Tech Canada Inc., Calgary, Alberta, Canada

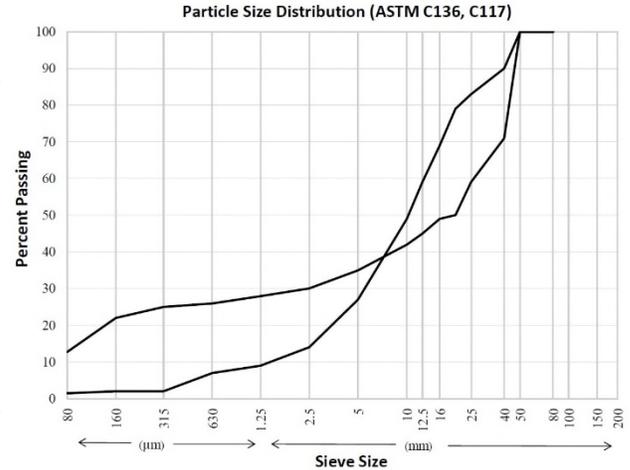
During the subsurface investigation the soils at the trenchless utility installation depth were generally described as gravel, which was sandy, silty, poorly graded, subrounded to subangular, wet, dense to very dense in consistency, and with trace cobbles. The groundwater table was measured at an approximate depth of 5.1 m below the existing ground surface and groundwater seepage was observed.

Figure 2 presents the particle-size analysis laboratory test results conducted on samples within the gravel deposit near the trenchless installation depth collected during the subsurface investigation at the borehole locations advanced in closest proximity to the track sinkhole.

Figure 2. Particle-Size Analysis Results in Soils Near the Sinkhole

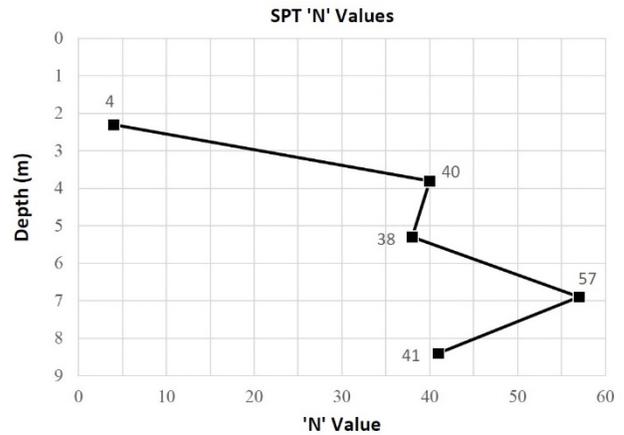
Figure 3 presents the results of the in situ Standard Penetration Testing (SPT) conducted at the borehole location advanced in closest proximity to the track sinkhole (approximate 5.0 m offset) in the soils overlying and at the casing installation location, organized by depth from the existing ground surface.

Figure 3. SPT Results in Soils Near the Sinkhole

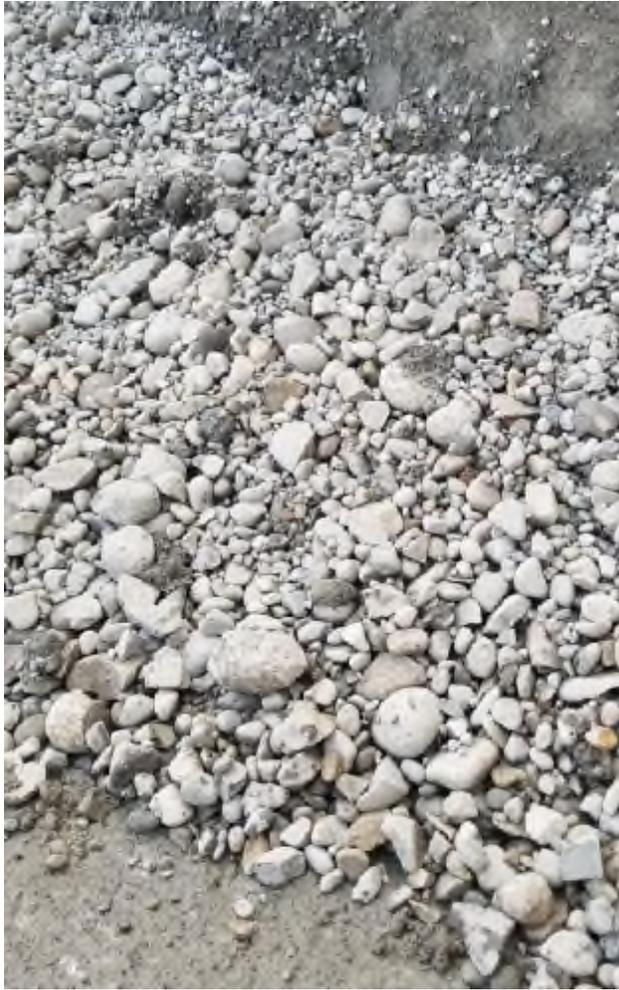
Photo 1 depicts the general soils removed during trenchless boring at the approximate location of the track sinkhole.

Photo 1. Soils Removed at Approximate Sinkhole Location

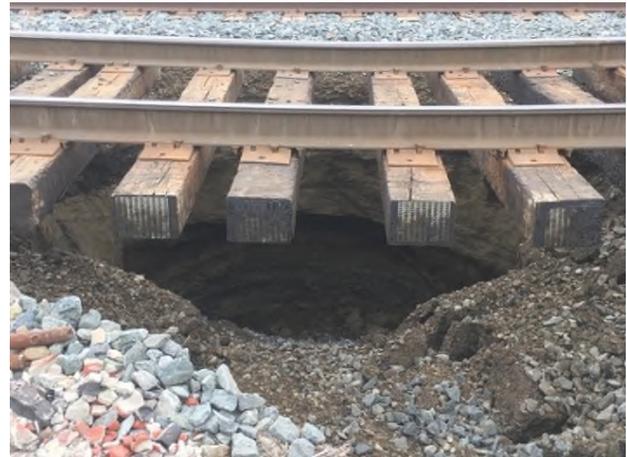
As the TBM progressed beneath the existing rails, ground loss at the trenchless installation boring depth propagated to an observable sinkhole at the existing ground surface immediately underlying the track structure. The resulting sinkhole is depicted in Photos 2 and 3.

Photo 2. Sinkhole Observed from Utility Alignment

Probable factors that may have contributed to the sinkhole event were suspected to include, but not necessarily limited to, saturated granular soils at install depth prone to sloughing, occurrence of groundwater seepage, inadequate communication during advancement, insufficient overcut control, and improper slurry/lubrication

1. Immediate shutdown of track operations.
2. Removal of the wooden sleepers and steel rails in the sinkhole area and initial backfill with granular fill/lean mix grout to limit further degradation of the track structure(s). Note that much of the area effected by the ground loss may be directly underlying and concealed by the existing surface materials; accordingly, equipment should approach the general sinkhole area with extreme caution and only following a visual assessment from qualified geotechnical personnel.

grout via subsurface injection. The remedial grouting program employed for This Project comprised open-ended pipe grouting and sleeve port pipe injection grouting.

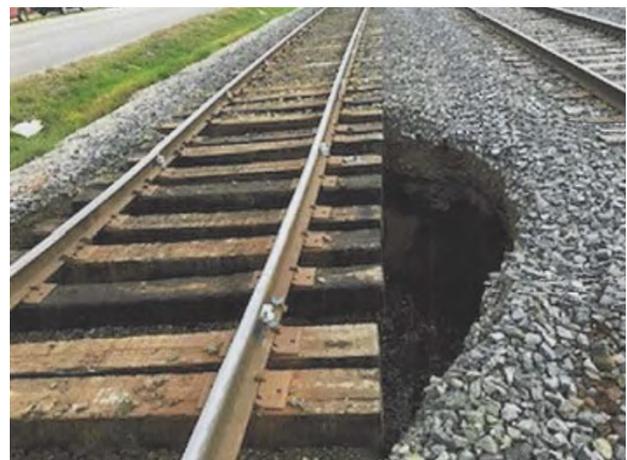
Photo 3. Sinkhole Observed from Rail Alignment

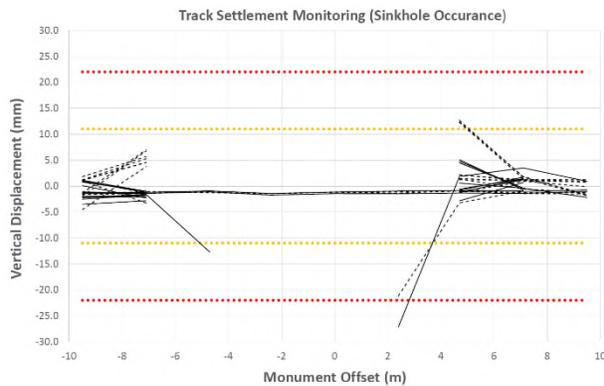
Figure 4. Track Settlement Monitoring Results at Sinkhole Occurrence

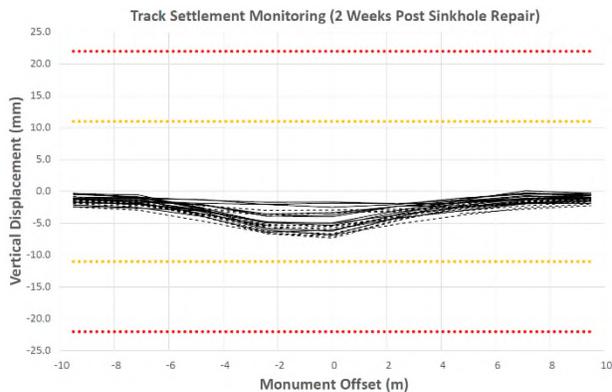
Figure 5. Track Settlement Monitoring Results (2 Weeks Post Sinkhole Repair)

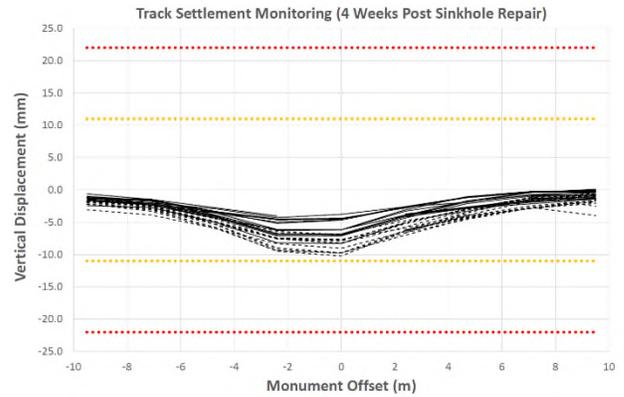
Figure 6. Track Settlement Monitoring Results (4 Weeks Post Sinkhole Repair)

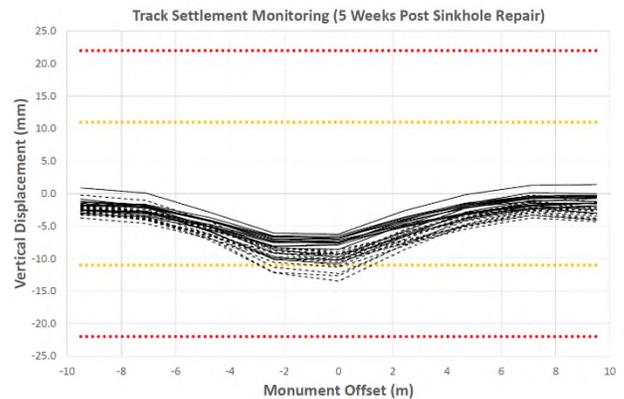
Figure 7. Track Settlement Monitoring Results (5 Weeks Post Sinkhole Repair)

Note that track maintenance through rail lifting, additional ballast placement, and tamping was conducted between the timeframes of Figure 7 (above) and Figure 8 (below), as mentioned as a potential requirement of the emergency 'Action Plan' in Section 5 (Item 7). This was conducted given a few of the rail monitoring point settlement measurements had once again reached the 'warning' level threshold (yellow dashed line).

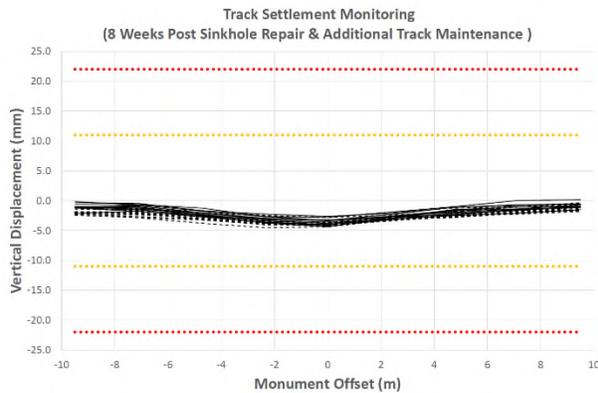
Figure 8. Track Settlement Monitoring Results (8 Weeks Post Sinkhole Repair and Additional Track Maintenance)

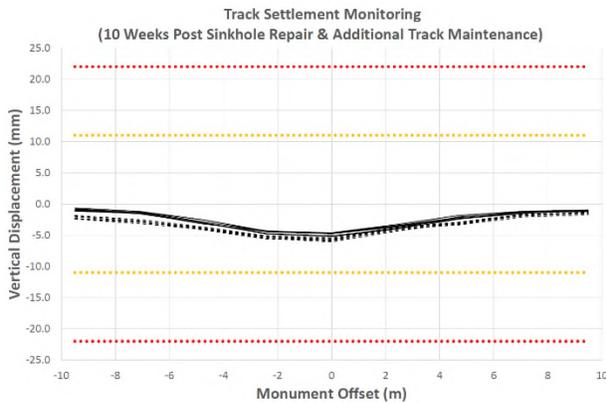
Figure 9. Track Settlement Monitoring Results (10 Weeks Post Sinkhole Repair and Additional Track Maintenance)
