Investigating static liquefaction as a potential mode of failure for Edenville dam via numerical simulation

Vincent Castonguay
Seequent, Calgary, AB, Canada

GeoCalgary
2022 October
2-5
Reflection on Resources

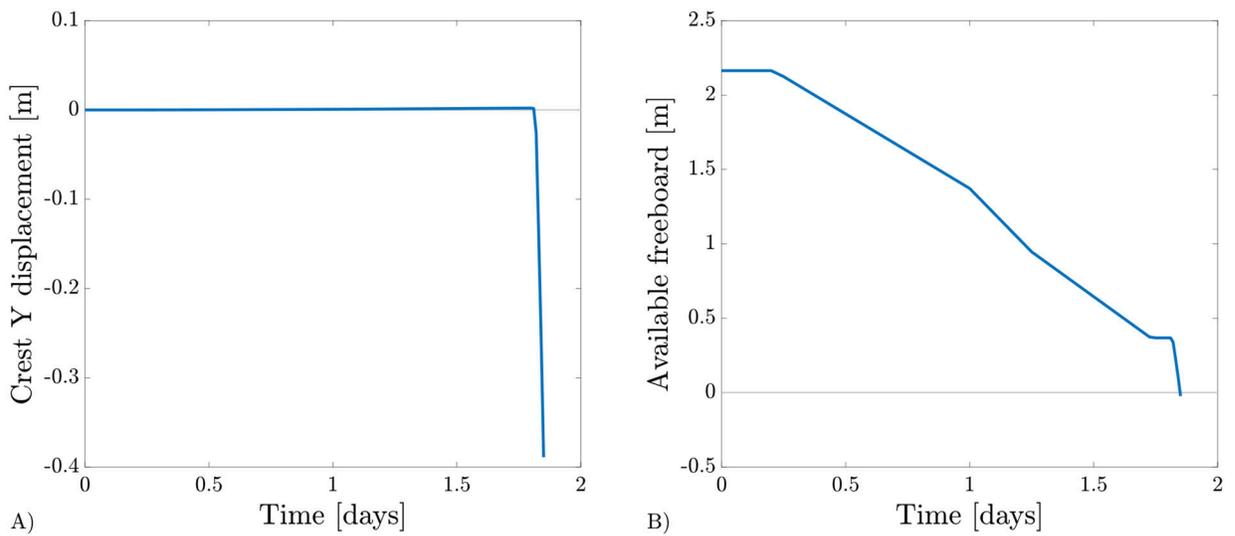
Figure 5. Crest vertical displacement (A) and available freeboard (B) during the rainfall event

Figure 5 A reports the vertical displacement of the top right corner of the dam crest as a function of time. Displacements are very small for most of the event, until large deformations start to accumulate at the 1.80-days mark (which corresponds to 19h12 on May 19th). The corresponding available freeboard is plotted in Figure 5 B. At the 1.85-day mark, the available freeboard becomes negative and the simulation is stopped. At this point, the reservoir level is higher than the dam's height, the dam cannot successfully retain the reservoir's content anymore. In other words, the retaining structure has failed to carry out its function.

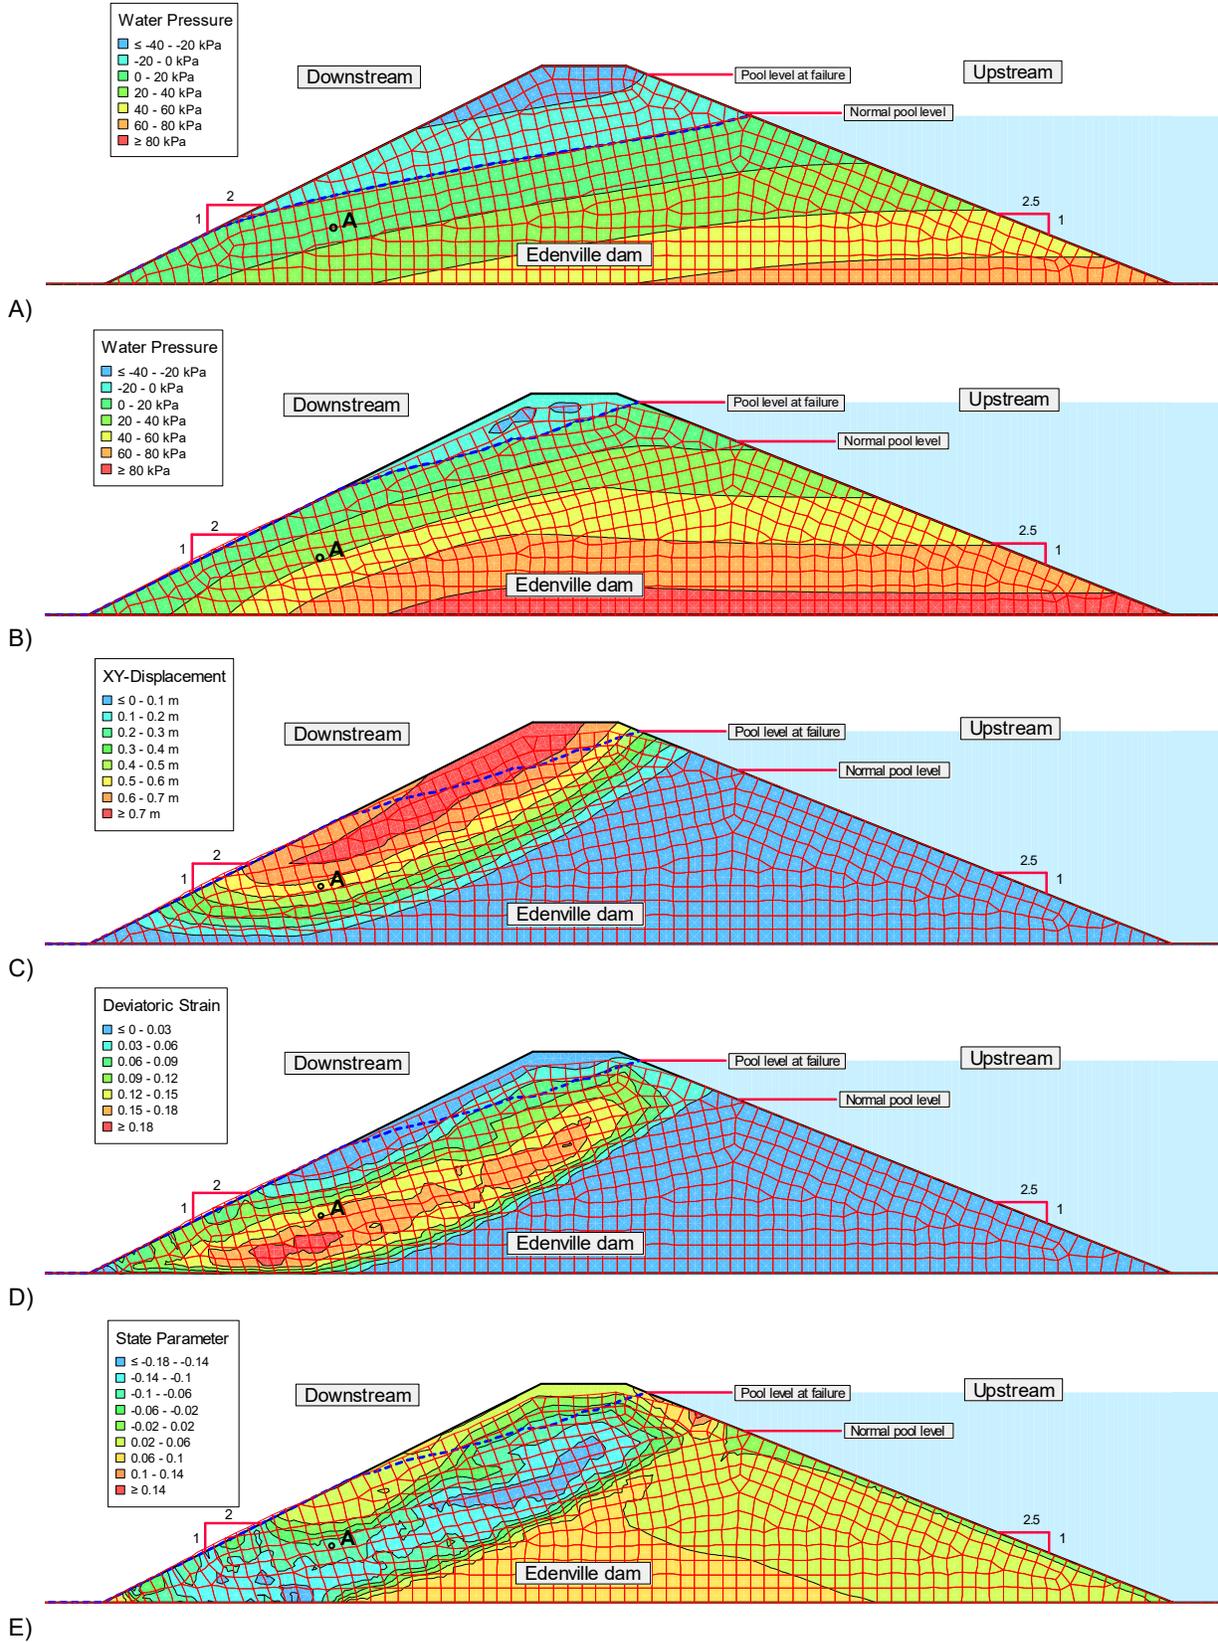
Figure 6. Simulation results at the 1.85-day mark: A) Initial pore-water pressure – B) Final pore-water pressure – C) XY Displacement – D) Deviatoric strain – E) State parameter

The pore-water pressure conditions in the dam at the beginning of the rainfall event are contoured in Figure 6 A and can be compared to the conditions at the 1.85-day mark contoured in Figure 6 B. The downstream side of the dam experiences an important increase in pore-water pressure due to the rising free surface inside the dam. An example of such increase is plotted for point A in Figure 7 C (this point is identified in the lower portion of the downstream side of the dam in Figure 6). At this point, the initial pore-water pressure went from 13.1 kPa at the beginning of the rainfall event, to 19.0 kPa at the 1.80-day mark (when excessive deformations began to accumulate), and ended up reaching 38.3 kPa at the 1.85-day mark when the dam failed.

XY deformations at the 1.85-day mark are contoured in Figure 6 C. The corresponding deformed mesh is also shown in red in Figure 6. The upper downstream side of the dam experiences the largest amount of deformations (upward of 0.7 m). The dam crest tilts toward the downstream side of the dam as a result of the large deformations that affect the general downstream portion of the dam.

The large XY deformations shown in Figure 6 C are caused by the shear band that develops in the lower downstream portion of the dam as the water level increases in the reservoir (Figure 6 D). Most of the strains sustained by the dam are concentrated in a band approximately 4 m large, extending from the toe on the downstream side to the area just below the crest on the upstream side. The toe on the downstream side experiences deformations first as the water level increases in the reservoir. Strains exacerbate in this area before extending to the rest of the shear band.

A contour of NorSand's state parameter ψ (Been and Jefferies, 1985) at the 1.85-day mark is shown in Figure 6 E. The state parameter is the difference between the current void ratio and the void ratio at critical state, at constant mean effective stress (see Equation 1). The state parameter is a good indicator of how dense ($\psi < 0$) or loose ($\psi > 0$) a soil is. As shown in Figure 6 E, the upstream side of the dam remains loose after the rainfall event. However, the shear band located on the

downstream side contains denser soils. The large deformations sustained by the dam in this zone brought the soils from an initially loose to a denser state (*i.e.* densification occurred).

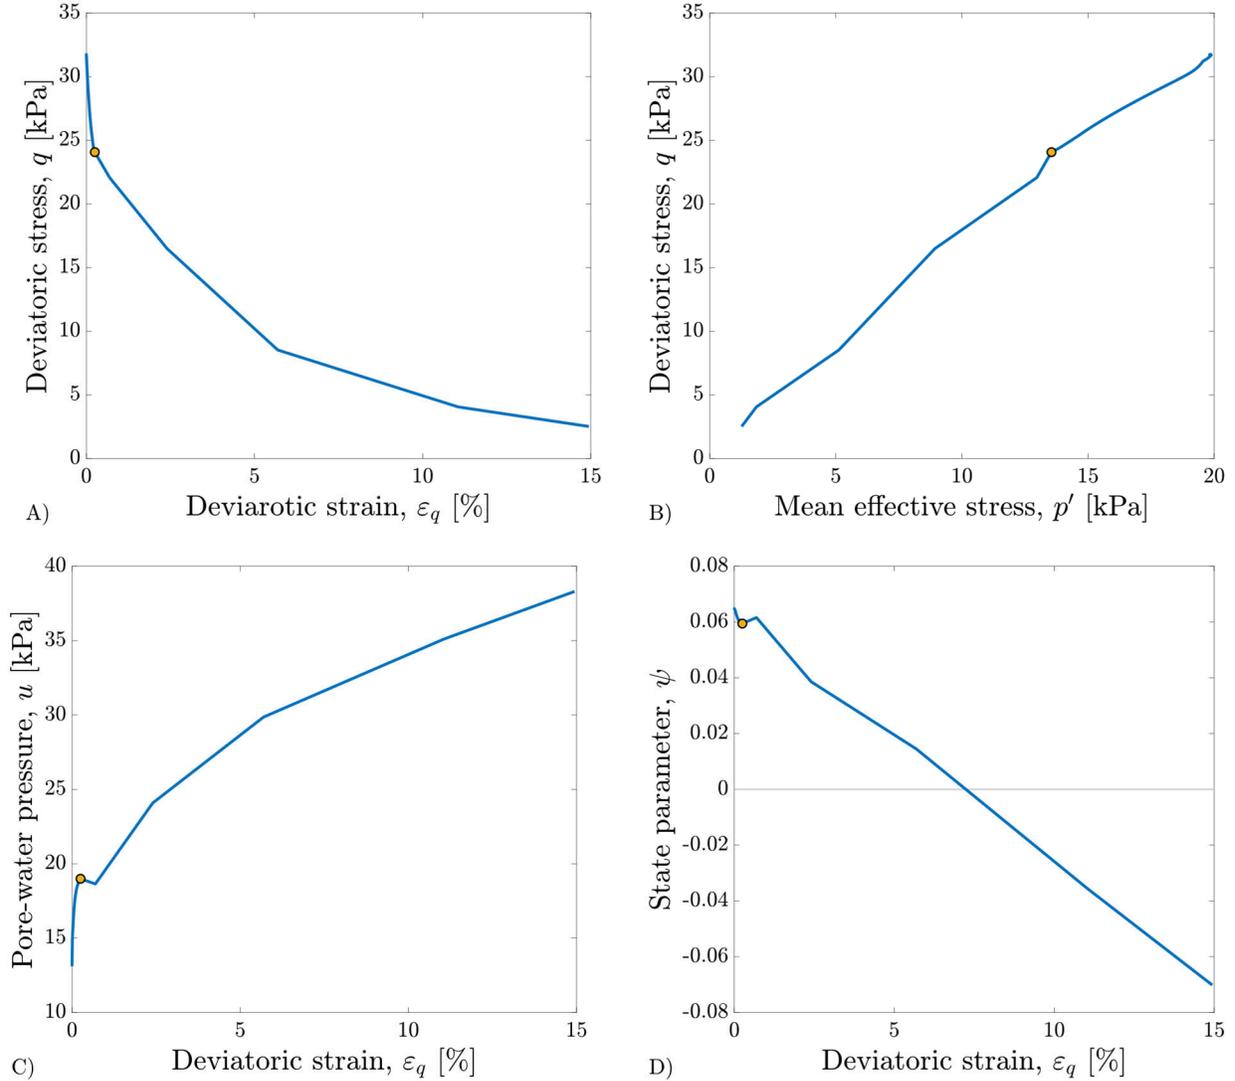
Figure 7. Simulation results at point A at the 1.85-day mark

Figure 7 shows the simulation results for point A, labeled in Figure 1 and Figure 6 (lower downstream portion of the dam). As evidenced in section B of the figure (stress path), the deviatoric stress in this area of the dam was already relatively large compared to the mean effective stress. At the start of the rainfall event, the mean effective stress was around 20 kPa and the deviatoric stress was around 32 kPa (stress ratio $\eta = 1.6$). As the pore-water pressure increased, the mean effective stress decreased, which was also accompanied by a deviatoric stress decrease. The yellow point indicated on the figure marks the onset of larger deformations at the 1.80-day mark. Section A of the figure clearly shows how deviatoric strain began rapidly increasing once this threshold was passed. At the yellow point, the pore-water pressure (Figure 7 C) rose very rapidly, which correspondingly brought the mean effective stress down (Figure 7 B). The end result is very low mean effective stresses, which translates into very low shear resistance and very large deformations. Interestingly, the state parameter (Figure 7 D) is propelled past the zero mark as large deformations accumulate (the crossing occurs at around 7 % of deviatoric strain). At this point, the soil is deforming very rapidly, densification occurs as the state parameter drops below zero.

The behaviour described above for point A amounts to static liquefaction. The very brutal and sudden increase in deformation within the shear band eventually leads to large displacements of the dam's crest and even to overtopping. This behaviour matches the video evidence of the failure readily available on the Internet.
