# NorSand modelling for evaluating the triggering of flowslides in loess

**GeoCalgary**  
2022 October  
2-5  
Reflection on Resources

## ABSTRACT

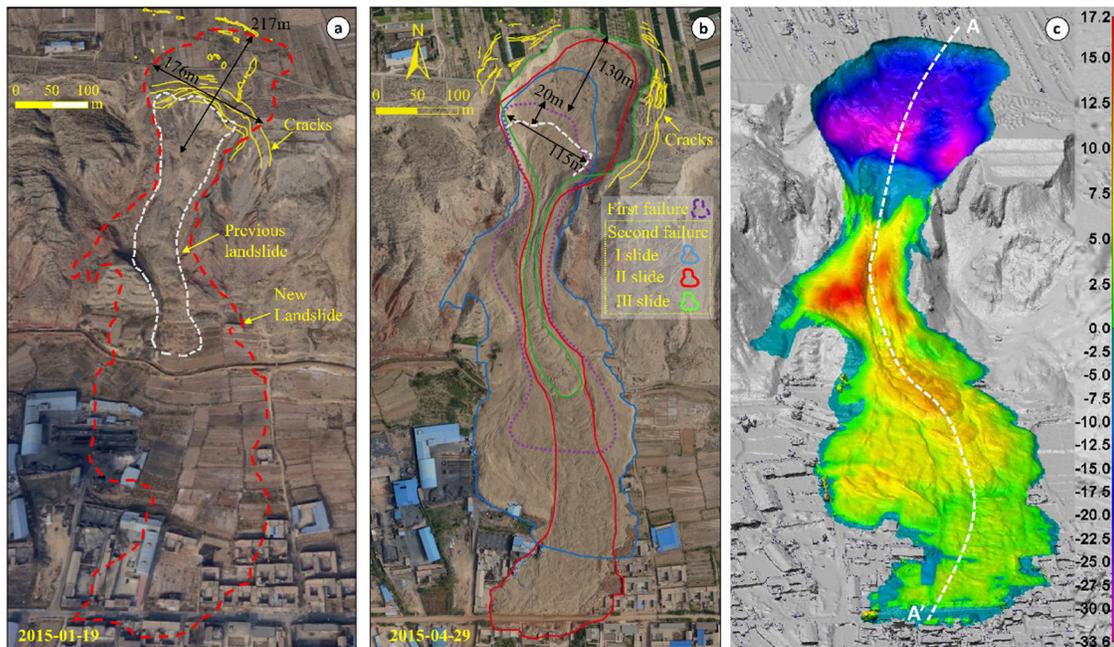
Xu et al. (2016) detailed the field investigation of the DC#2 loess flowslide and conducted a preliminary analysis of the failure. The work documented important field data for the deformation analysis. The field monitoring of the DC#2 flowslide indicated two failures within 4 hrs. The first failure appeared to be a localized failure, while the second was a flowslide involving a much larger mass of material. The combined failures resulted in a retreat of more than 130 m with a runout distance of 789 m (Fig. 1). The estimated total volume of the failure is  $32.4 \times 10^4 \text{ m}^3$ .

The ground markers placed behind the scarp showed small cumulative displacements three months prior to the initial failure, which occurred around 7:50 AM on April 29, 2015, followed up by a flow failure at 10:47 AM on the same day (Qi et al. 2018). No evident deformation was found between the first failure and at least 2 hrs prior to the flow failure. The flow failure involved three individual sliding events within about 4 minutes. The first and second sliding events each resulted in about 60 m of slope retreat. The third sliding appears to be more localized and occurred on both flanks of the second sliding (Fig. 1).

Figure 1. The DC#2 retrogressive loess flowslides occurred in HFT on April 29, 2015: a) pre-failure oblique aerial view of DC#2; b) post-failure oblique aerial view of DC#2 showing three sliding events for the retrogressive failure; and c) pre/post-failure difference in the Digital Elevation Model with the cross-section line A-A' (after Qi et al. 2018).

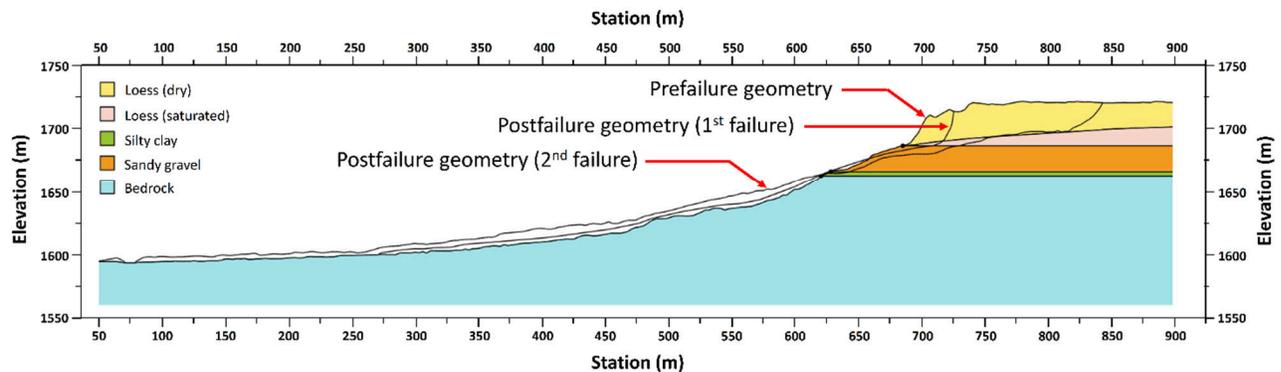
Figure 2 presents the pre- and post-failure geometry of the DC#2 flowslide. At a depth of 20 m, the HFT loess sample has an initial void ratio range from 0.86-0.89 and a silt content (0.005-0.075 mm) of 87.9%, with a specific gravity of 2.69-2.71 and an *in situ* water content of about 8%. The average liquid and plastic limits of the samples are  $w_L = 26.8\%$  and  $w_P = 17.5\%$ , with a plastic index  $PI = 9.3$ , which is slightly above the A-line and classified as CL. With a saturated water content readily over 100% and  $w_c/w_L > 0.85$ , the HFT loess is susceptible to liquefaction based on the criteria proposed by Bray and Sancio (2006).

Figure 2. Simplified pre-failure geometry overlaying the approximate post-failure geometries of the first and second (flow) failures of the DC#2 loess flowslide for deformation analysis (location of the cross-section profile A-A' shown in Fig. 1).

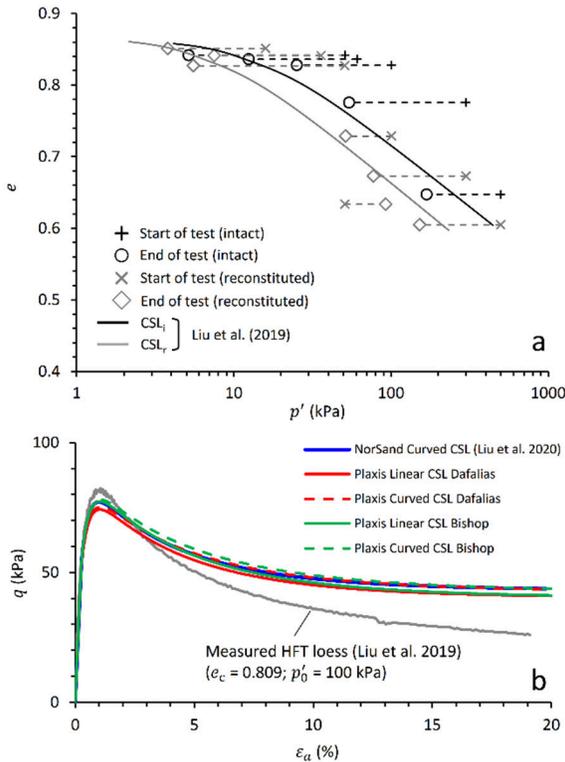
Liu et al. (2020) calibrated the *NorSand* model for the intact and reconstituted silty HFT loess under low-stress levels. The *NorSand* parameters are listed in Table 2. Several approximations are needed; for example, a curved CSL is idealized to fit the samples, and the effect of the structure is replicated by introducing an overconsolidation ratio (OCR) of 1.5. The output data from the Visual Basic (VB)-based *NorSand* simulation is similar to the results from the PLAXIS-based *NorSand* simulation using the same parameters, as illustrated in Figure 3.

Figure 3. a) The CSLs used for modelling the undrained behaviours of the HFT loess (both intact and reconstituted specimens are included) (after Liu et al. 2019) and b) Calibration of undrained behaviours of intact HFT loess at  $p'_0 = 100$  kPa with the difference between VB-based and PLAXIS-based *NorSand* simulation.

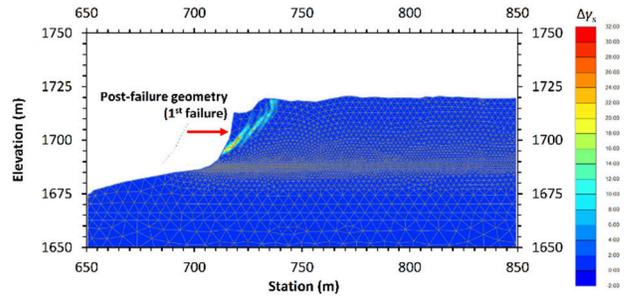
Similar to the observation by Jin et al. (Jin et al. 2022), the loess slope was in an unstable state immediately after the first failure, with an evident critical slip surface as illustrated by the incremental deviatoric strain (Fig. 4).

Figure 4. The incremental deviatoric strain  $\Delta\gamma_s$  immediately after the first failure.

It is postulated that the loess slope must respond to the 'debuttressing' due to the first failure near the toe area. This provides a possibility for lateral movement at this location, which leads to strain-weakening propagating upwards into the saturated loess layer. In addition to this possible lateral movement, the first failure will introduce a new hydraulic gradient and result in the convergence of groundwater behind the scarp of the first failure.

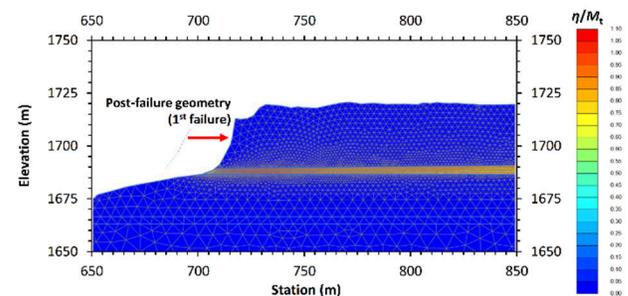
Figure 5. Distribution of controlling stress ratio in the DC#2 flowslide after the first failure.

The normalized stress ratio,  $\eta/M_t$ , reflects the degree of mobilization of the strength of the soil (Fig. 5). A value of

unity for this ratio indicates that the soil has reached the critical state with continuous deformation at constant load. The red zone indicates that the failure initiates at the toe area and propagates throughout the saturated loess layer. The plastic points in PLAXIS confirm the likely locations of liquefaction near the toe area, as shown in Fig. 6.

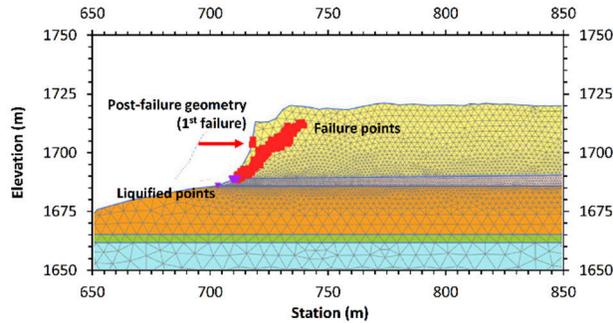
Figure 6. Plastic points of the DC#2 flowslide after the first failure.

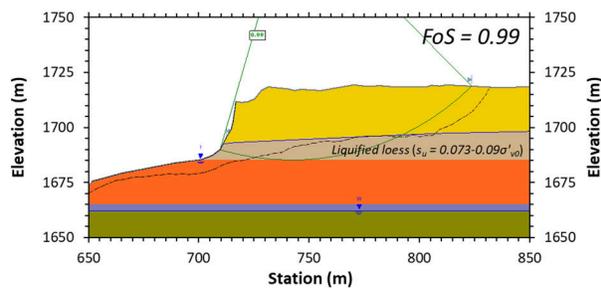
These findings are consistent with the observations based on the back-calculation using the limit equilibrium method (Jin et al. 2022) with a liquified shear strength,  $s_u(\text{LIQ}) = 0.073\text{--}0.09 \sigma'_{v0}$  (Fig. 7).

Figure 7. The critical slip surface of the fully-softened loess under an undrained condition with a retreat of the scarp of approx. 120 m behind the first failure (after Jin et al. 2022).
