# Hydrojacking Case in Plutonic Rock Mass

Baisre Carlos A. Geological Engineer. P. Eng. M.Sc.A.  
Consulting Engineer. Brossard, QC, Canada  
carlosbaisre@gmail.com

## ABSTRACT

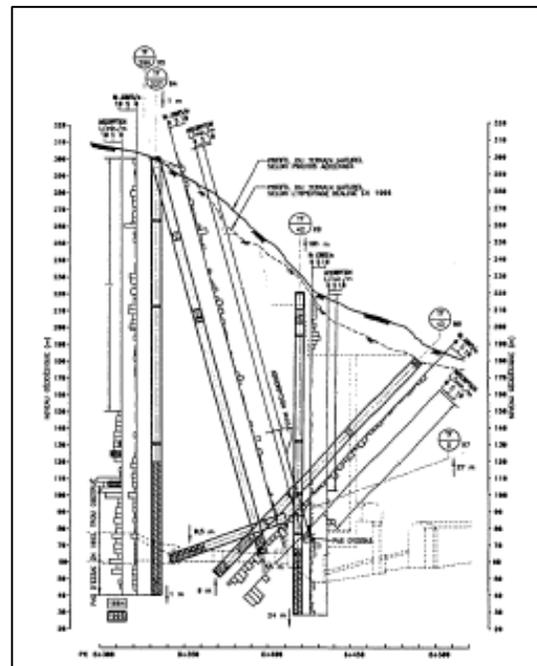
The underground complex is located in a topographic nose (Figure 1). The rock mass is a batholith of anorthositic composition with random intrusions of amphibolite, pegmatite and aplite.

Figure 1: Site investigation at the powerhouse area.

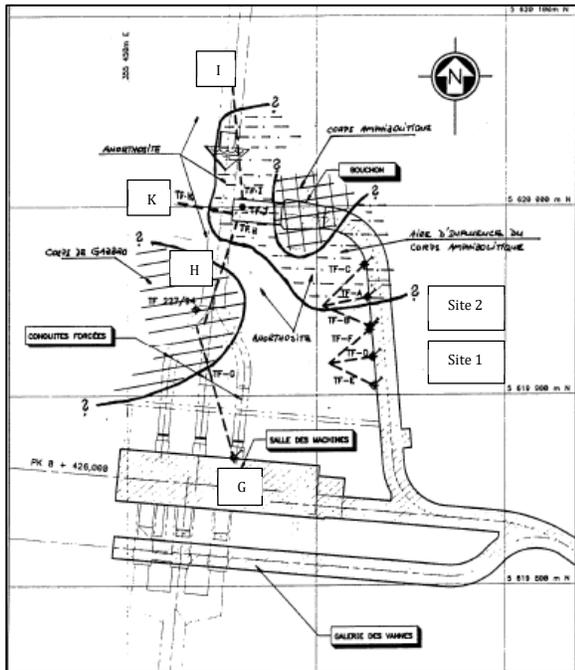
There are two important intrusions, a gabbro body located in the power tunnel, penstocks and part of the powerhouse and a smaller amphibolite body in the access gallery (Figure 2). These two bodies play a very important role, specifically the gabbro, in defining the geological structures around the powerhouse, influencing their orientation and the level of the in-situ stress.

Figure 2: Underground excavation status in 1997. Doorstoppers and hydrojacking test locations. Interpreted intrusive bodies.

In May of 1997, only the access gallery, and the top headings of the gates gallery and of the powerhouse were excavated. An underground verification of the stress level for the penstocks steel lining lengths, was planned with doorstopper cells tests which were carried out on two adjacent sites (1 and 2), located in the access gallery at a depth of 242m. Three boreholes in each site (Figure 2) oriented towards the penstocks location.

The results obtained with doorstopper measurements combined to a numerical simulation led to the conclusion that the low vertical stress was not high enough to avert a hydrojacking event. Considering this fact, later in 1997, hydrojacking tests were carried out at the end of the access gallery (Figure 2). Four boreholes were drilled covering the area of influence of the shear. The obtained results are presented in Table 2, which shows a variety of stresses in function of the boreholes orientation and of the intercepted geological structures.

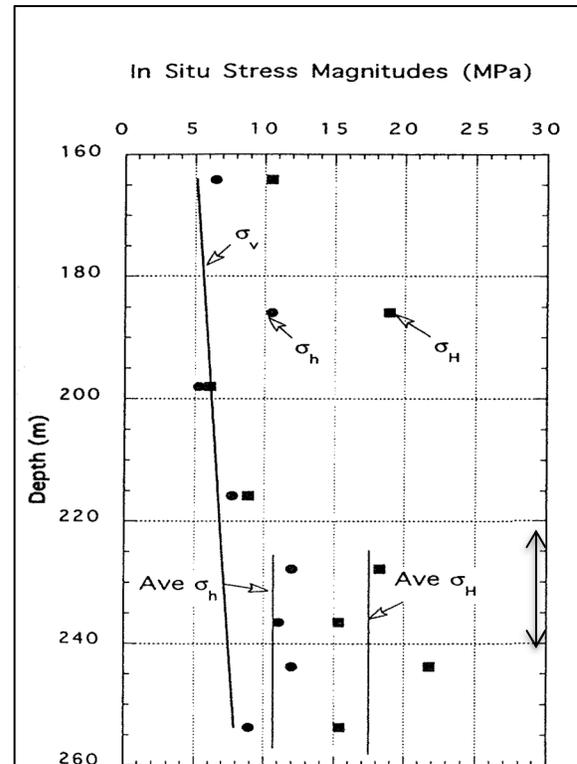
During the 1994 site investigation, hydrofracturing tests were conducted in a vertical borehole (TF-227) from the ground down to the manifold. Figure 3 presents the test results. The arrow indicates approximately the depth location of the manifold-powerhouse (242-220m).

Between 190 and 220m of depth the in-situ stress is significant lower. At the time, it was stated that the rock mass was strong enough to withhold the hydrostatic pressure of 3,2 MPa.

Figure 3: Hydrofracturing stress results.

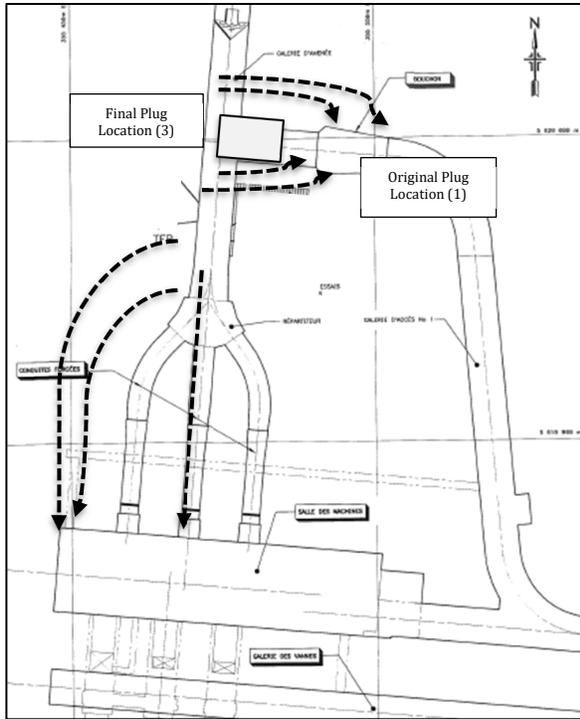
Table 5 presents the most relevant values obtained from the analysis including different hypothesis and many variants of the concrete plug locations and lengths. The calculations were useful to assess the magnitude of the problem, and for dimensioning the pumps to face the increasing amounts of water. Figure 5 presents the principal flow orientations and the water discharge areas.

Figure 4: Principal flow paths and discharge areas.
