Concrete Strength Variation and Curing Effect on the Crosshole Sonic Logging (CSL) Results of Cast-in-place (CIP) Concrete Piles

Jason Ni, M.Eng., P.Eng., Zhidong Zhou, Ph.D.
PrairieGEO Engineering Ltd., Calgary, Alberta, Canada

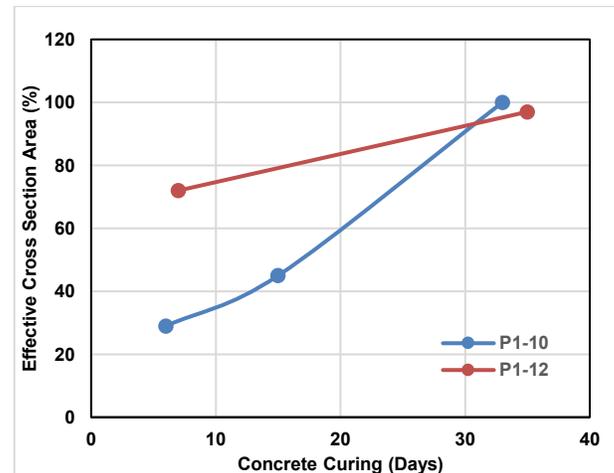
Variations of effective cross-section area versus concrete curing time are illustrated in Figure 1.

Figure 1. Effective Cross-Section Area vs Concrete Curing Time

Piles P1-02, P1-10 and P1-12 were retested to verify if further concrete curing would improve the CSL ratings. Table 4 shows a summary of retesting results of those three piles.

It is noted that Piles P1-10 and P1-12 have reached the satisfactory rating during the CSL retests at 33 and 35 days after concrete placement. However, Pile P1-02 indicates no improvement from “No Signal (NS)” during the retest. Piles P1-10 and P1-12 exhibit signal transferred during the original test, which have been also improved with additional concrete curing.

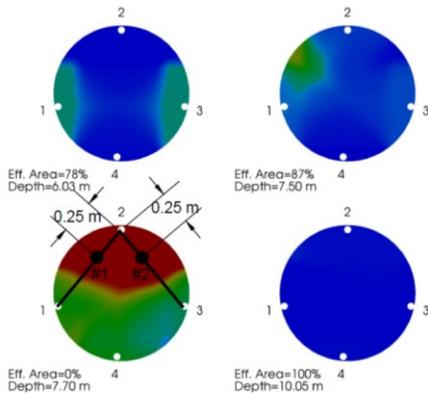
After CSL retesting, Piles P1-02 and P1-15 still indicate potential issues of concrete integrity or possible debonding of CSL access tubes. However, it is not very likely that all four access tubes all deboned at the same depths. Therefore, a coring plan was proposed to visually inspect the concrete condition for Piles P1-02 and P1-15. Based on tomography analysis results, the

proposed coring locations are depicted in Figures 2 and 3.

Figure 2. Proposed Coring Hole Plan for P1-02

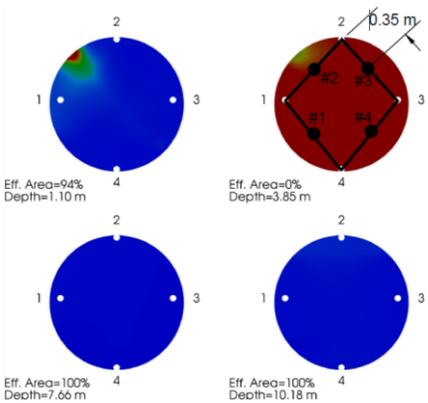
Figure 3. Proposed Coring Hole Plan for P1-15

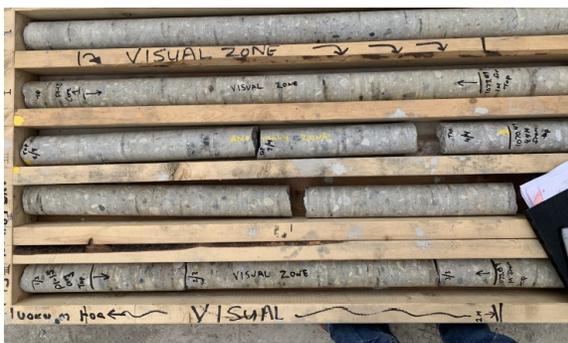
A sample photograph of cored concrete from Pile P1-15 is shown in Figure 4.

Figure 4. Concrete Core from pile P1-15

From on-site core inspection, no physical concrete integrity problems such as voids or other abnormalities are observed at the questionable depth of each pile. However, the compressive strength test of the concrete cores has indicated a relatively large variation in compressive strength, as summarized in the following table.

The axial compressive strengths of concrete cores collected at anomaly zones are verified to be varied from 39.1 to 51.4 MPa of Pile P1-02, and 35.4 to 50.2 MPa of Pile P1-15.
