Geotechnical Bedrock Characterization, Centre Block Rehabilitation Project, Ottawa Ontario

David Feghali⁽¹⁾, Steve Ash⁽²⁾, Imad Alainachi⁽²⁾ & Ahmed Abdelaziz⁽²⁾

⁽¹⁾WSP Canada, Nanaimo, British Columbia, Canada

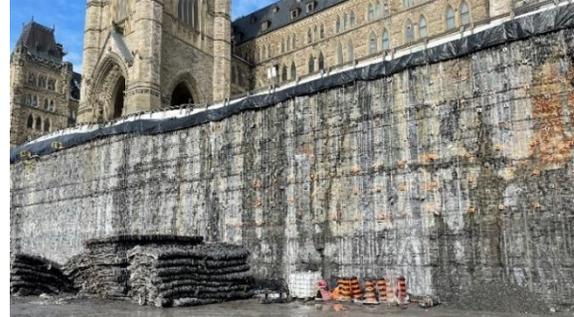
Figure 2: PWC partial north excavation face (Peace Tower foundation middle left).

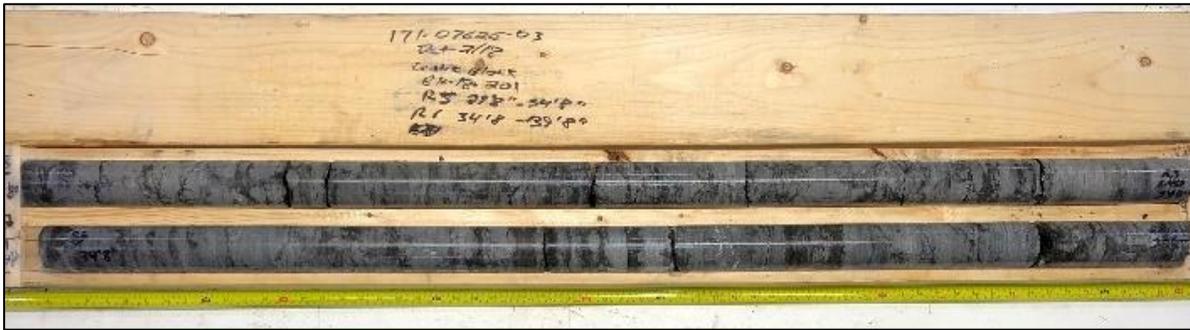
Figure 3: Bedded limestone and shale rock core recovered from one the boreholes.
