# Impacts to Highway 8 British Columbia due to the November 2021 Atmospheric River Event

Michael J. Laws

Ryan Edmonds

**GeoCalgary**  
2022<sup>October</sup>  
2-5  
Reflection on Resources

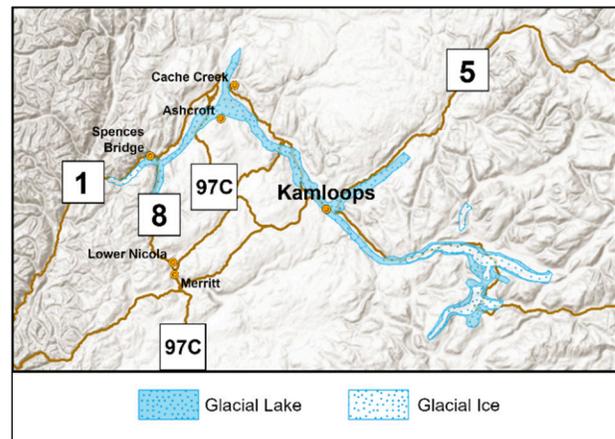
Figure 11. Approximate Extents of Glacial Lakes/Ice

The presence of glaciolacustrine deposits corresponds with the glacial-lake evolution stages of both Glacial Lake Thompson (high stage) and Glacial Lake Deadman (low stage), both of which extended partway up the Nicola River Valley from the confluence with the Thompson River (Johnsen et al. 2004). Figure 11 depicts the approximate extents of glacial lakes and ice formation.

The glacial drift and glaciolacustrine deposits are predominant at Sites 4, 5, 8, 10, 11, 13, 15, 18 and 21. The drift material generally comprises a wide variety of gravels and sands, interspersed with minor quantities of fine-grained materials. The glaciolacustrine deposits are predominantly sands and fine-grained materials and are typically located closer to the Nicola River confluence with the Thompson River.
