Trenchless Utility Installation Ground Loss Soil Stabilization Emergency Action Plan for Rail Tracks – Case Study

Mr. Kyle L. Haugrud, P.Eng., Senior Geotechnical Engineer
Mr. Joseph Yonan, Ph.D., P.Eng., Principal Geotechnical Consultant
Tetra Tech Canada Inc., Calgary, Alberta, Canada

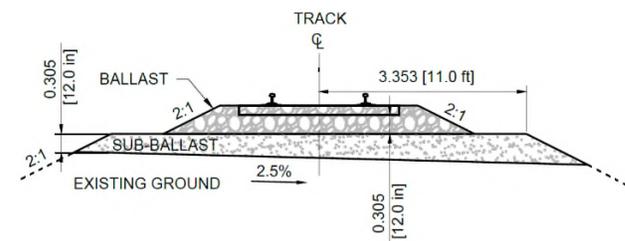
Figure 1. General Rail Track Structure Layout

Figure 1 presents The Project general rail structure configuration, which includes a soil subgrade (as discussed in Section 2), granular sub-ballast material, granular ballast material, and wooden sleepers fastened to steel rails.
