Investigating static liquefaction as a potential mode of failure for Edenville dam via numerical simulation

Vincent Castonguay
Seequent, Calgary, AB, Canada

GeoCalgary
2022 October
2-5
Reflection on Resources

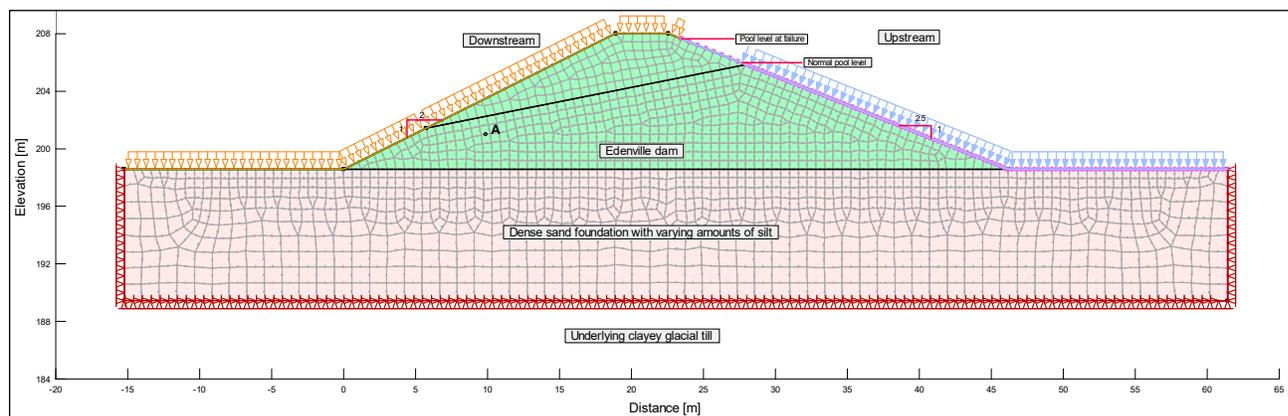
Figure 1. Geometry and meshing of the domain

The model geometry used replicates the description made in section 2.1 and is shown in Figure 1. Quadrilateral finite elements with secondary nodes (a total of eight calculation nodes per element) were used. The finite elements have an approximate size of 0.6 m. Elements are allowed to be twice this size near the edges of the domain to reduce the number of calculation nodes. Secondary nodes are turned off in the upper portion of the dam geometry to allow for faster solve times in the unsaturated zone, where more limited deformations are expected.

The boundary conditions used for the simulations are shown in Figure 1 and summarized in Table 2.

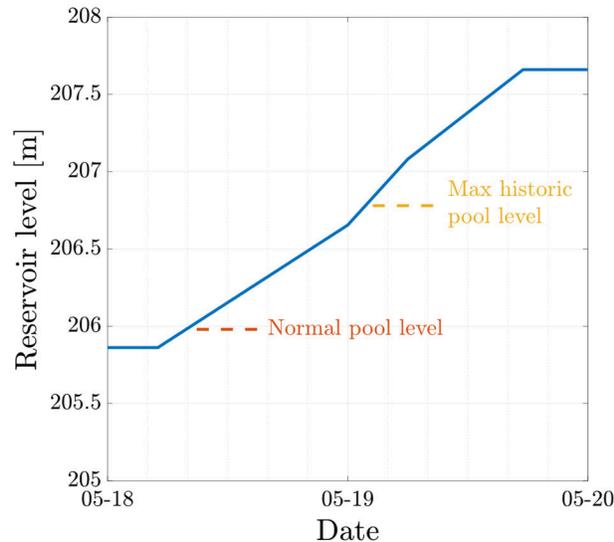
Figure 2. Reservoir level increase during the rainfall event

Step 4 of the modelling sequence presented in Table 1 reproduces the reservoir level behind Edenville dam, during the rainfall event that led to failure. The modelled reservoir level with respect to time is shown in Figure 2. The levels and times used are those reported by the IFT.

The simulation starts at midnight on May 18th. The reservoir level is then slightly below the normal operational pool level, at 205.86 m. At 5:00 AM that day, the reservoir level begins to rise. At midnight on May 19th, the reservoir level reaches 206.65 m, which was 0.67 m above the normal operational pool level, and just 0.13 m below the maximum historic pool level (recorded in 1929). The reservoir level continues to increase on May 19th, surpassing the maximum historic pool level, and reaching a maximum elevation of 207.66 m when failure occurred at 5:35 PM that day.

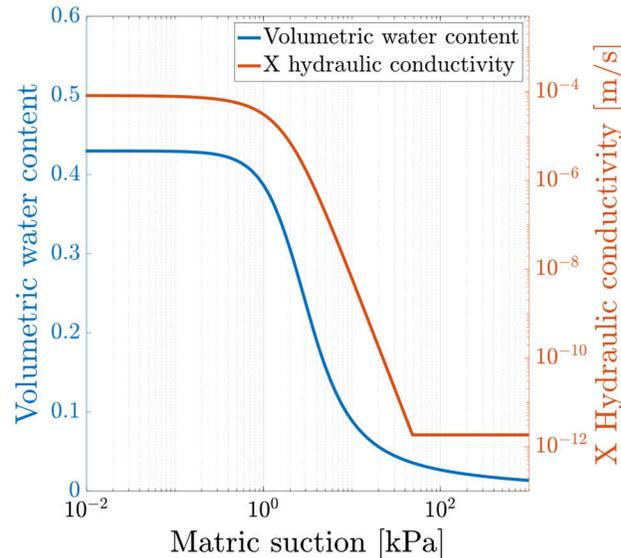
Figure 3. Volumetric water content and horizontal hydraulic conductivity of the dam material

The dam body is simulated as a saturated/unsaturated material, since unsaturated flow will occur above the water table within the dam. Conversely, the foundation is simulated as a saturated-only material since it is unlikely unsaturated flow develops in this zone. Since no information was made available by the IFT about the hydraulic flow properties of the dam material or the foundation, plausible estimates based on values proposed by Carsel and Parrish (1988) are made regarding the input parameters used (shown in Table 4). SEEP/W’s built-in estimation functions are used to estimate both the volumetric water content and horizontal hydraulic conductivity functions used for the saturated/unsaturated model of the dam material (shown in Figure 3).

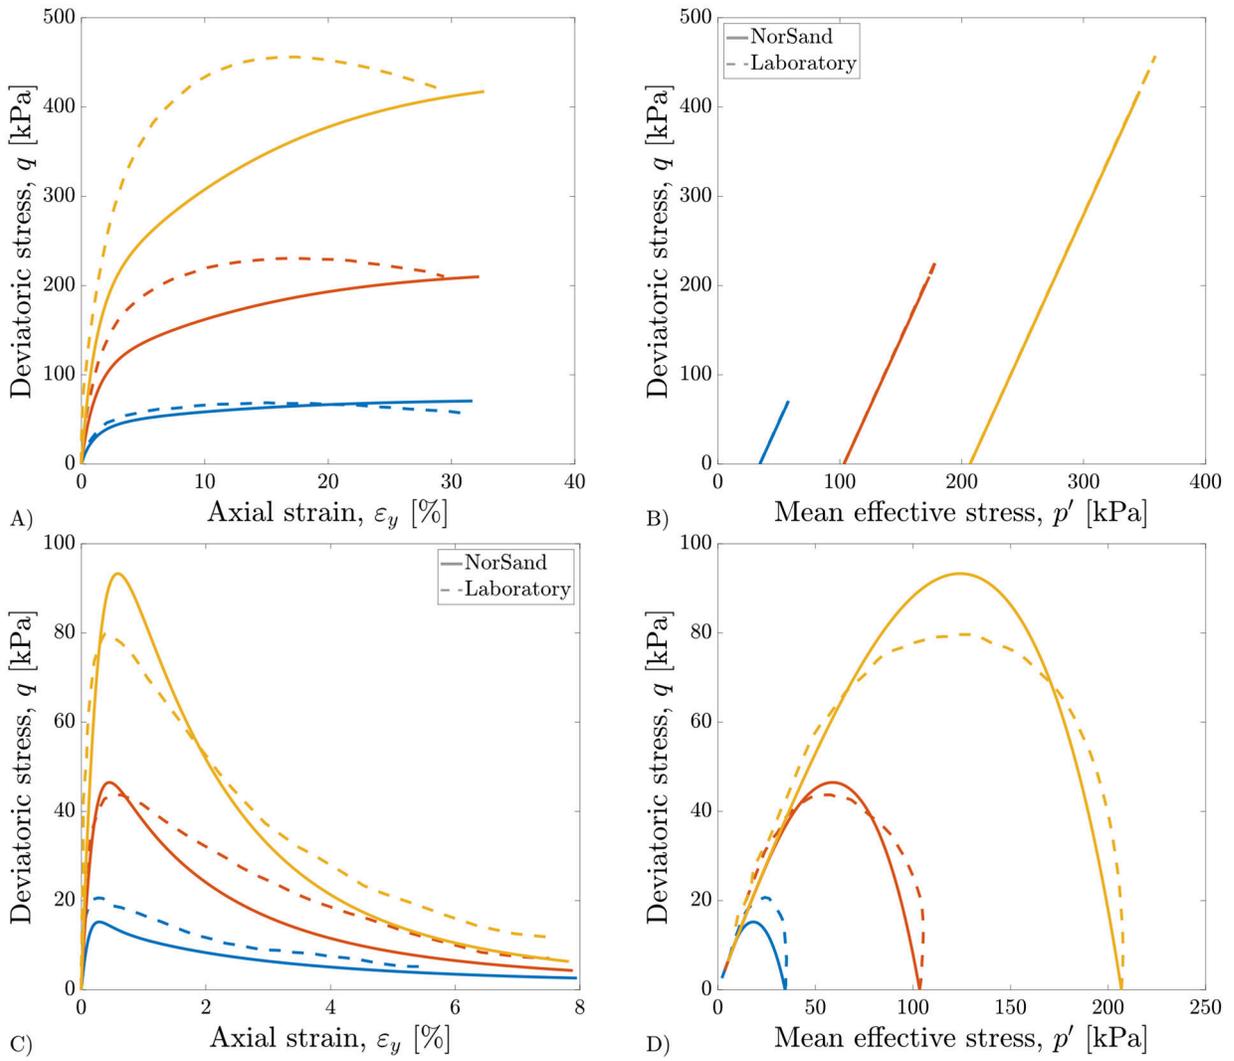
Figure 4. Comparison between drained (A-B) and undrained (C-D) laboratory triaxial compression tests and NorSand

Figure 4 shows the triaxial compression test results provided in the IFT report (dashed lines). Each color represents a different initial confining pressure. Drained tests are shown in sections A and B of the figure, while undrained tests are shown in sections C and D. Also shown in Figure 4 are the NorSand simulation results (plain lines) matching the laboratory results provided by the IFT. Using the NorSand input parameters shown in Table 4, NorSand compares quite favorably with the laboratory test results.

In essence, Figure 4 shows an excellent agreement between the laboratory results and the NorSand simulations, irrespective of testing conditions (drained or undrained) and initial confinements. Of crucial importance for this study, the undrained test series (parts C and D of Figure 4) display NorSand's ability to strongly contract when sheared from a loose initial state. The behaviour captured in the laboratory and correctly simulated by NorSand in these tests amounts to static liquefaction. More on that topic in section 5.1.
